REPORT NUMBER: 301-MGA-2009-008

**SAFETY COMPLIANCE TESTING FOR FMVSS 301R
FUEL SYSTEM INTEGRITY – REAR IMPACT**

**HYUNDAI MOTOR COMPANY
2009 HYUNDAI AZERA GLS
NHTSA NUMBER: C90507**

**PREPARED BY:
MGA RESEARCH CORPORATION
5000 WARREN ROAD
BURLINGTON, WI 53105**

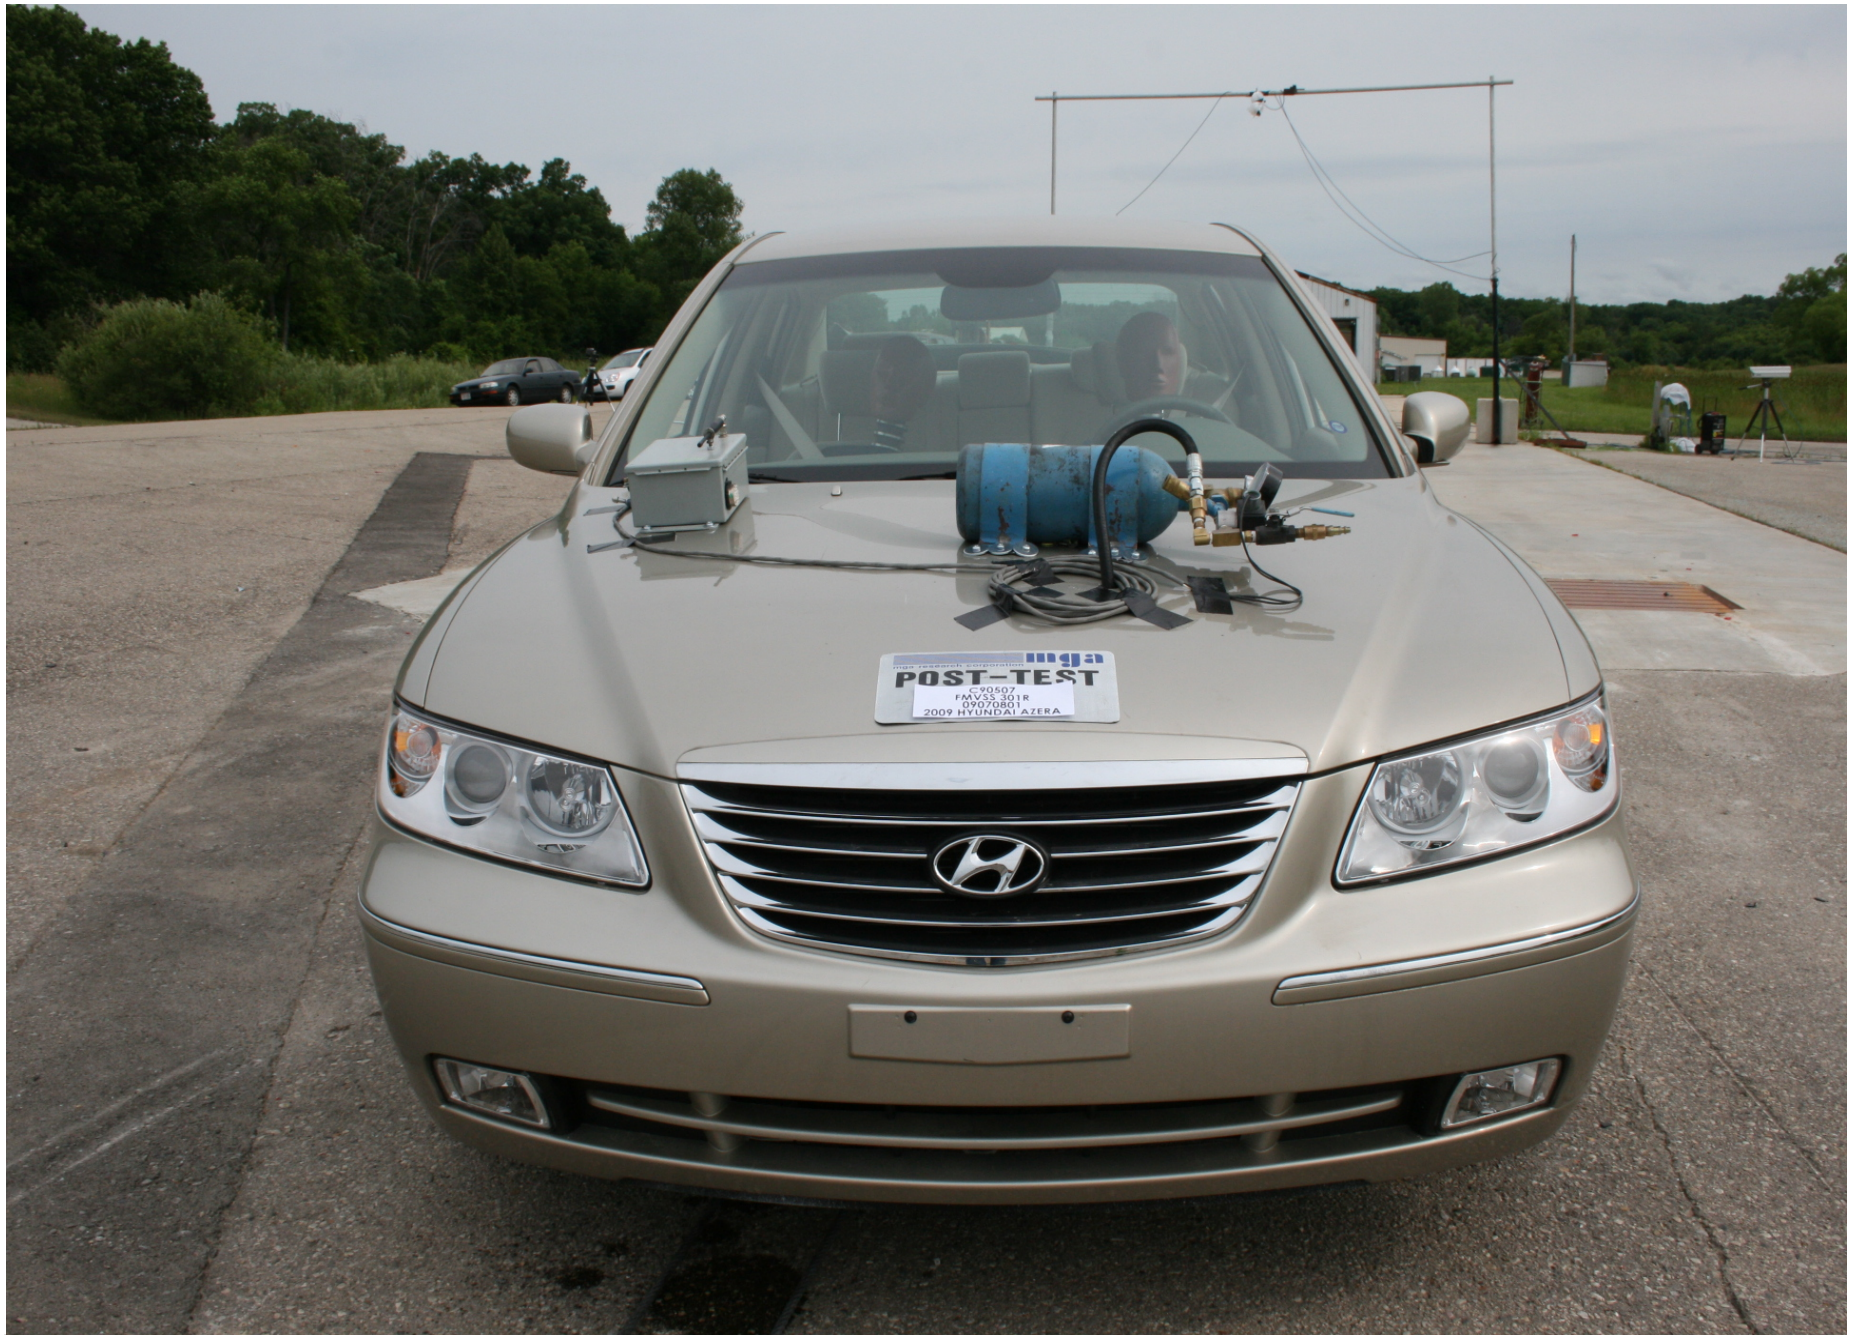
Post-Test Front View of Vehicle

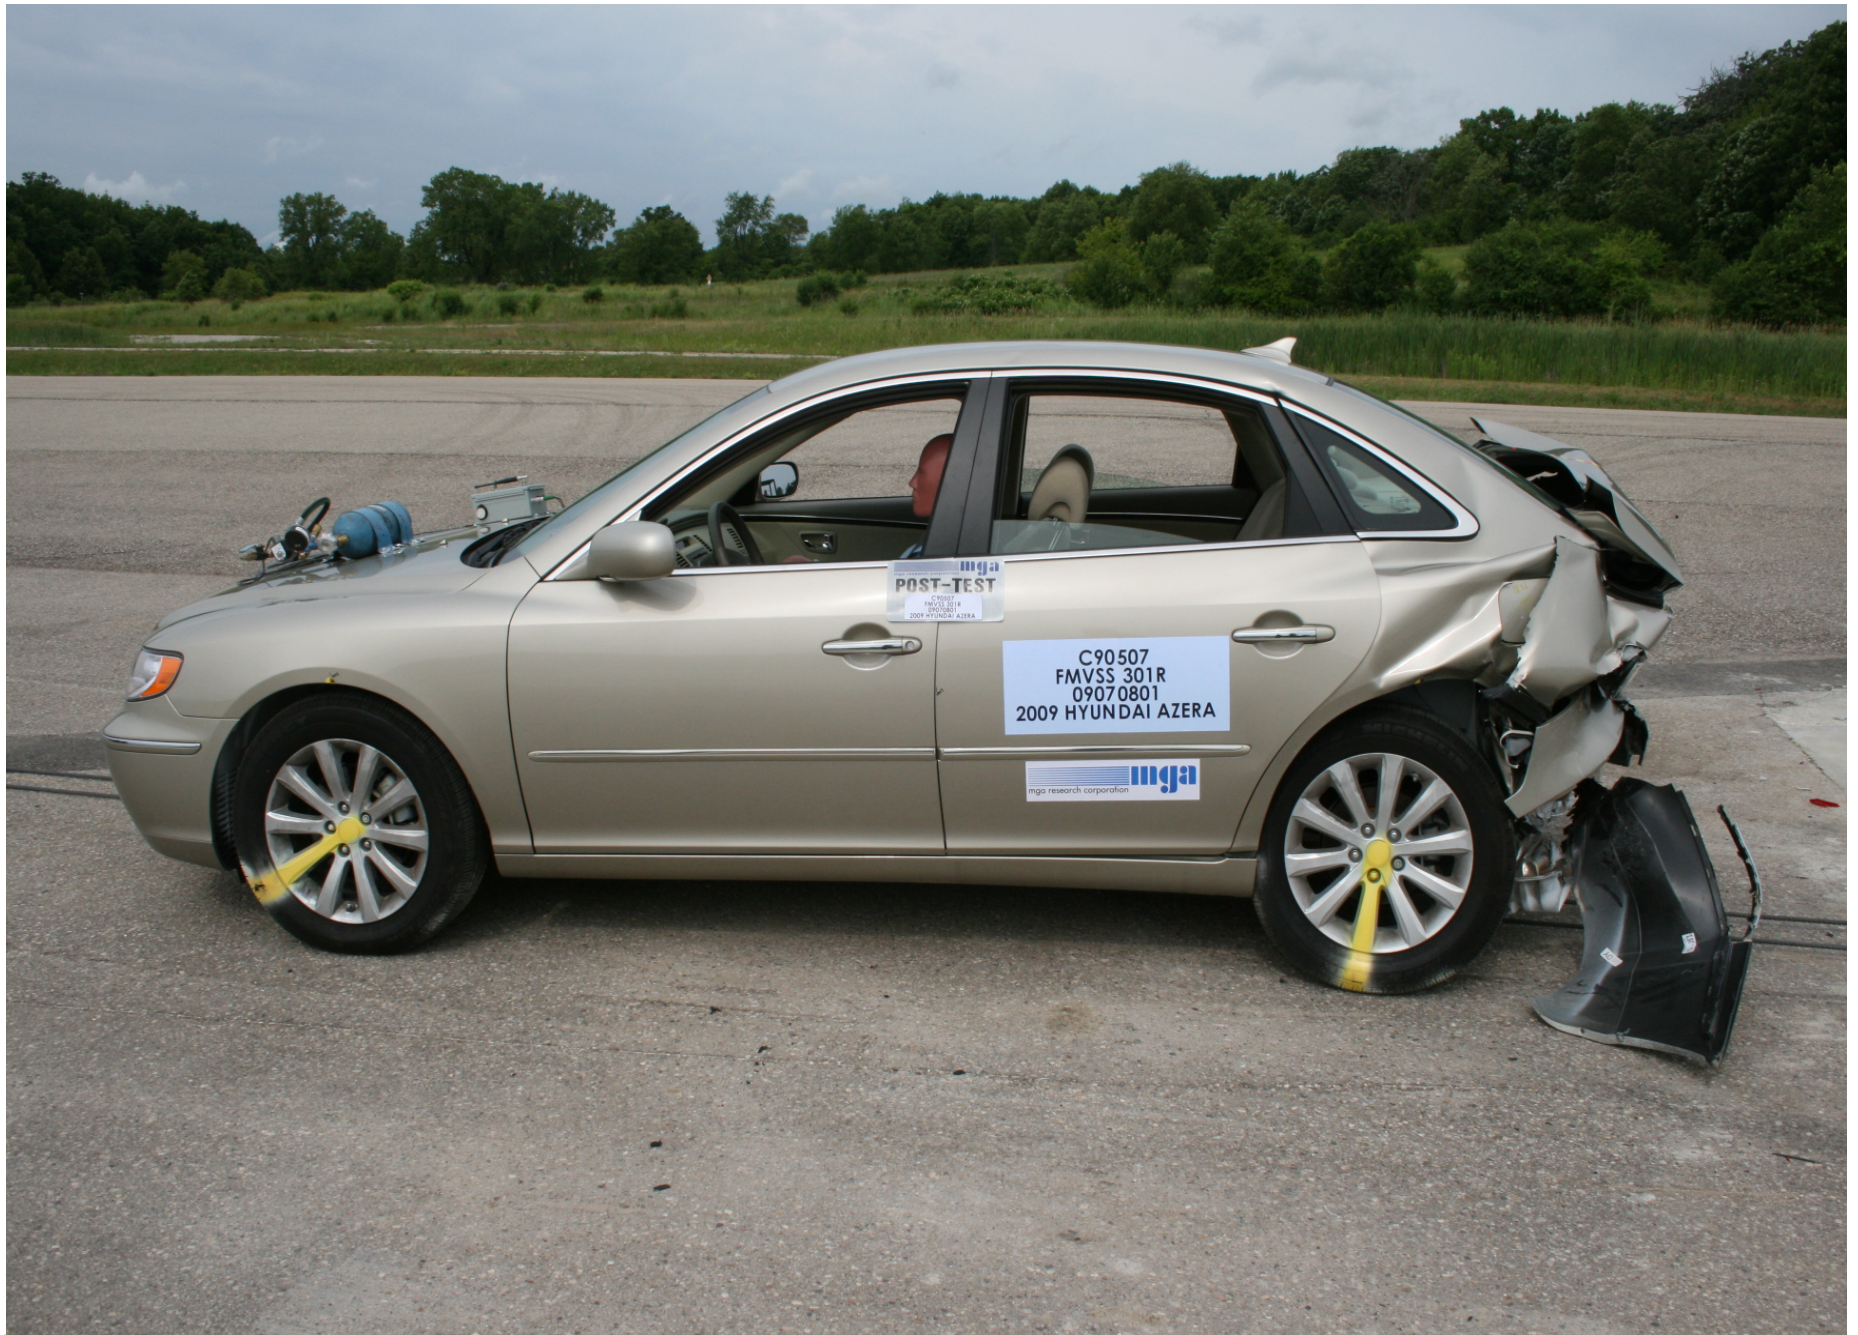
Post-Test Left Side View of Vehicle

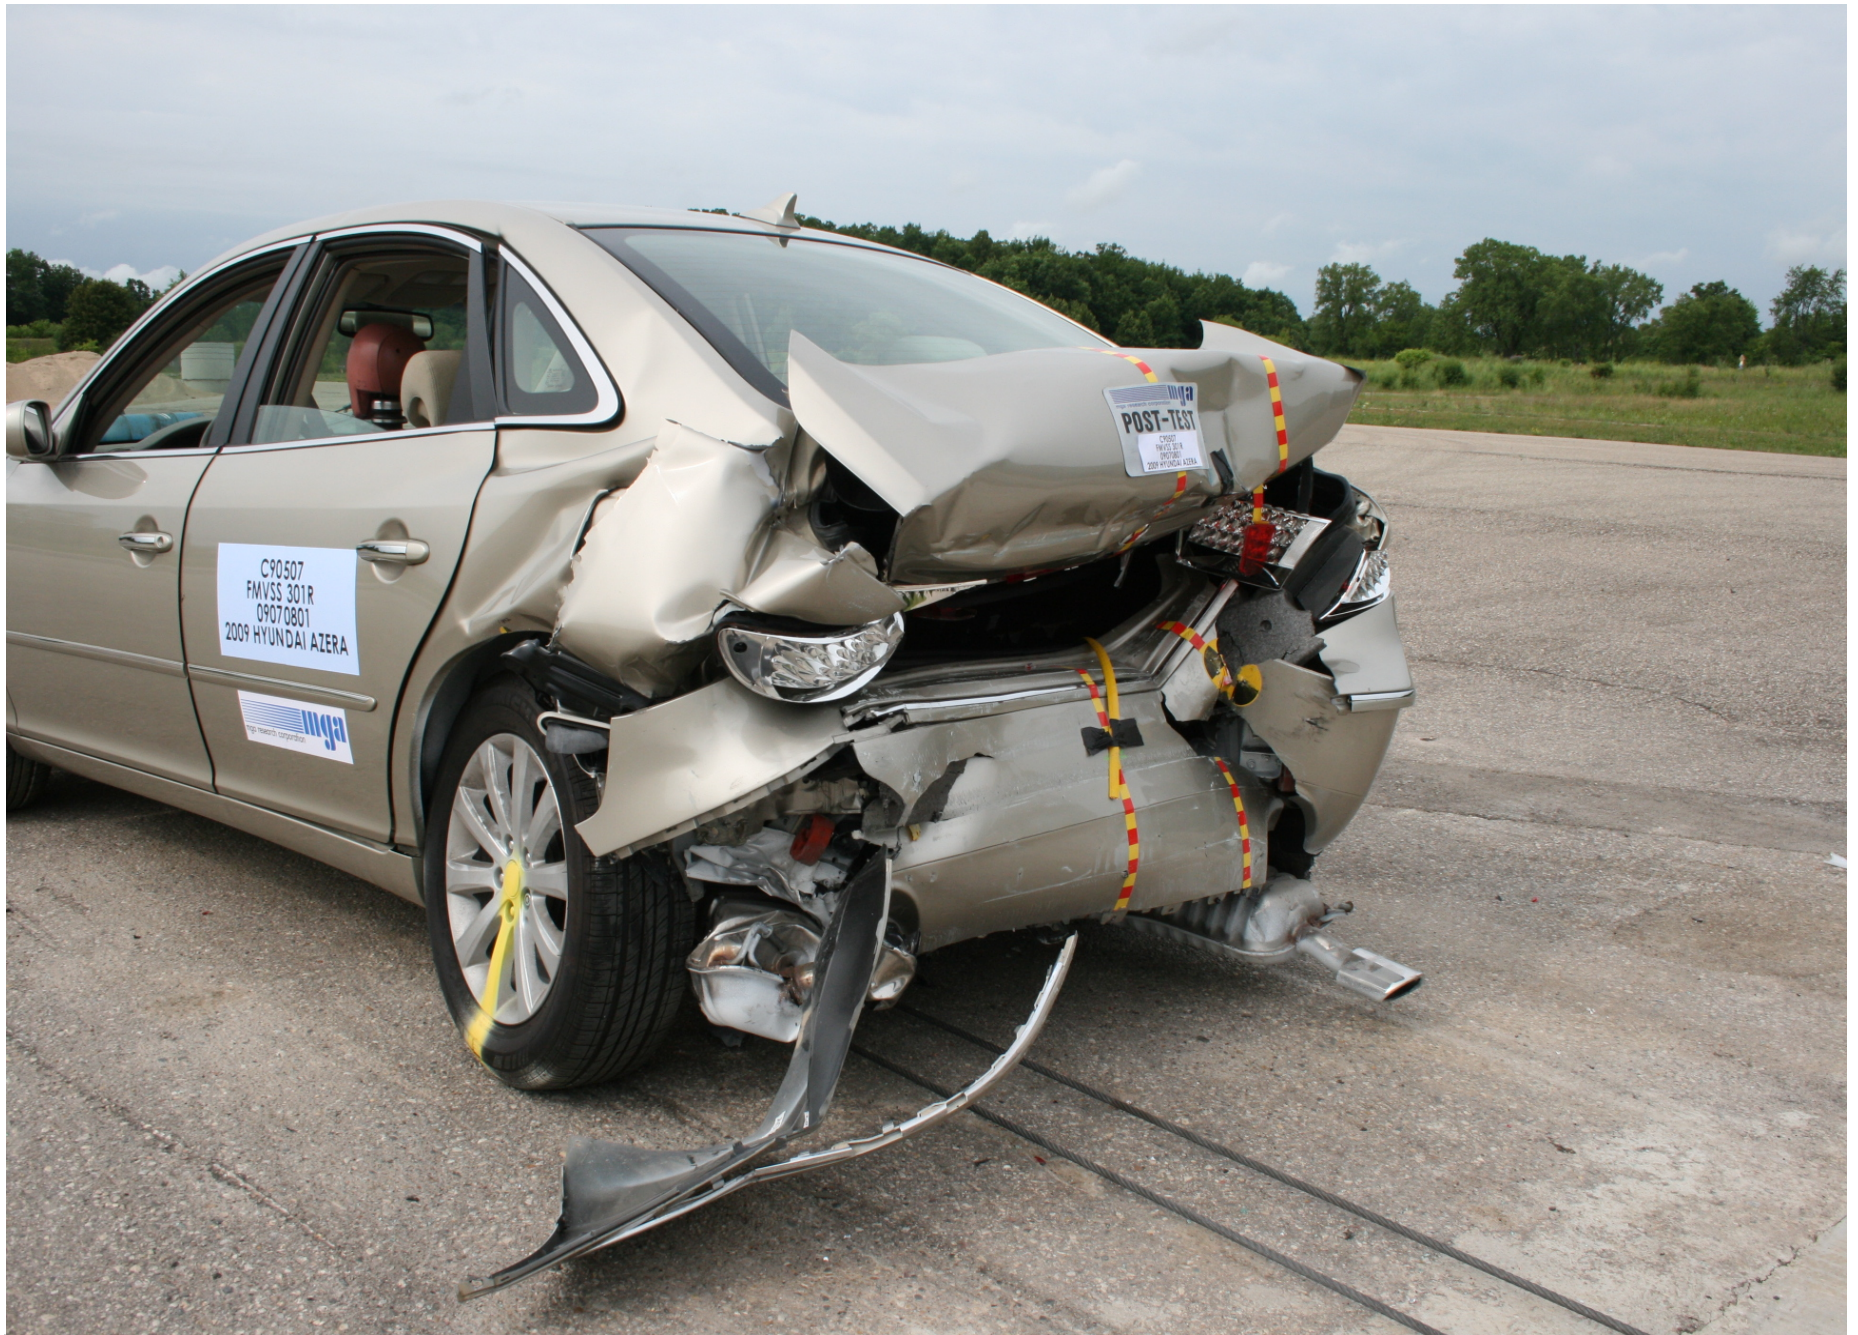
Post-Test Left Rear Close-up View of Vehicle

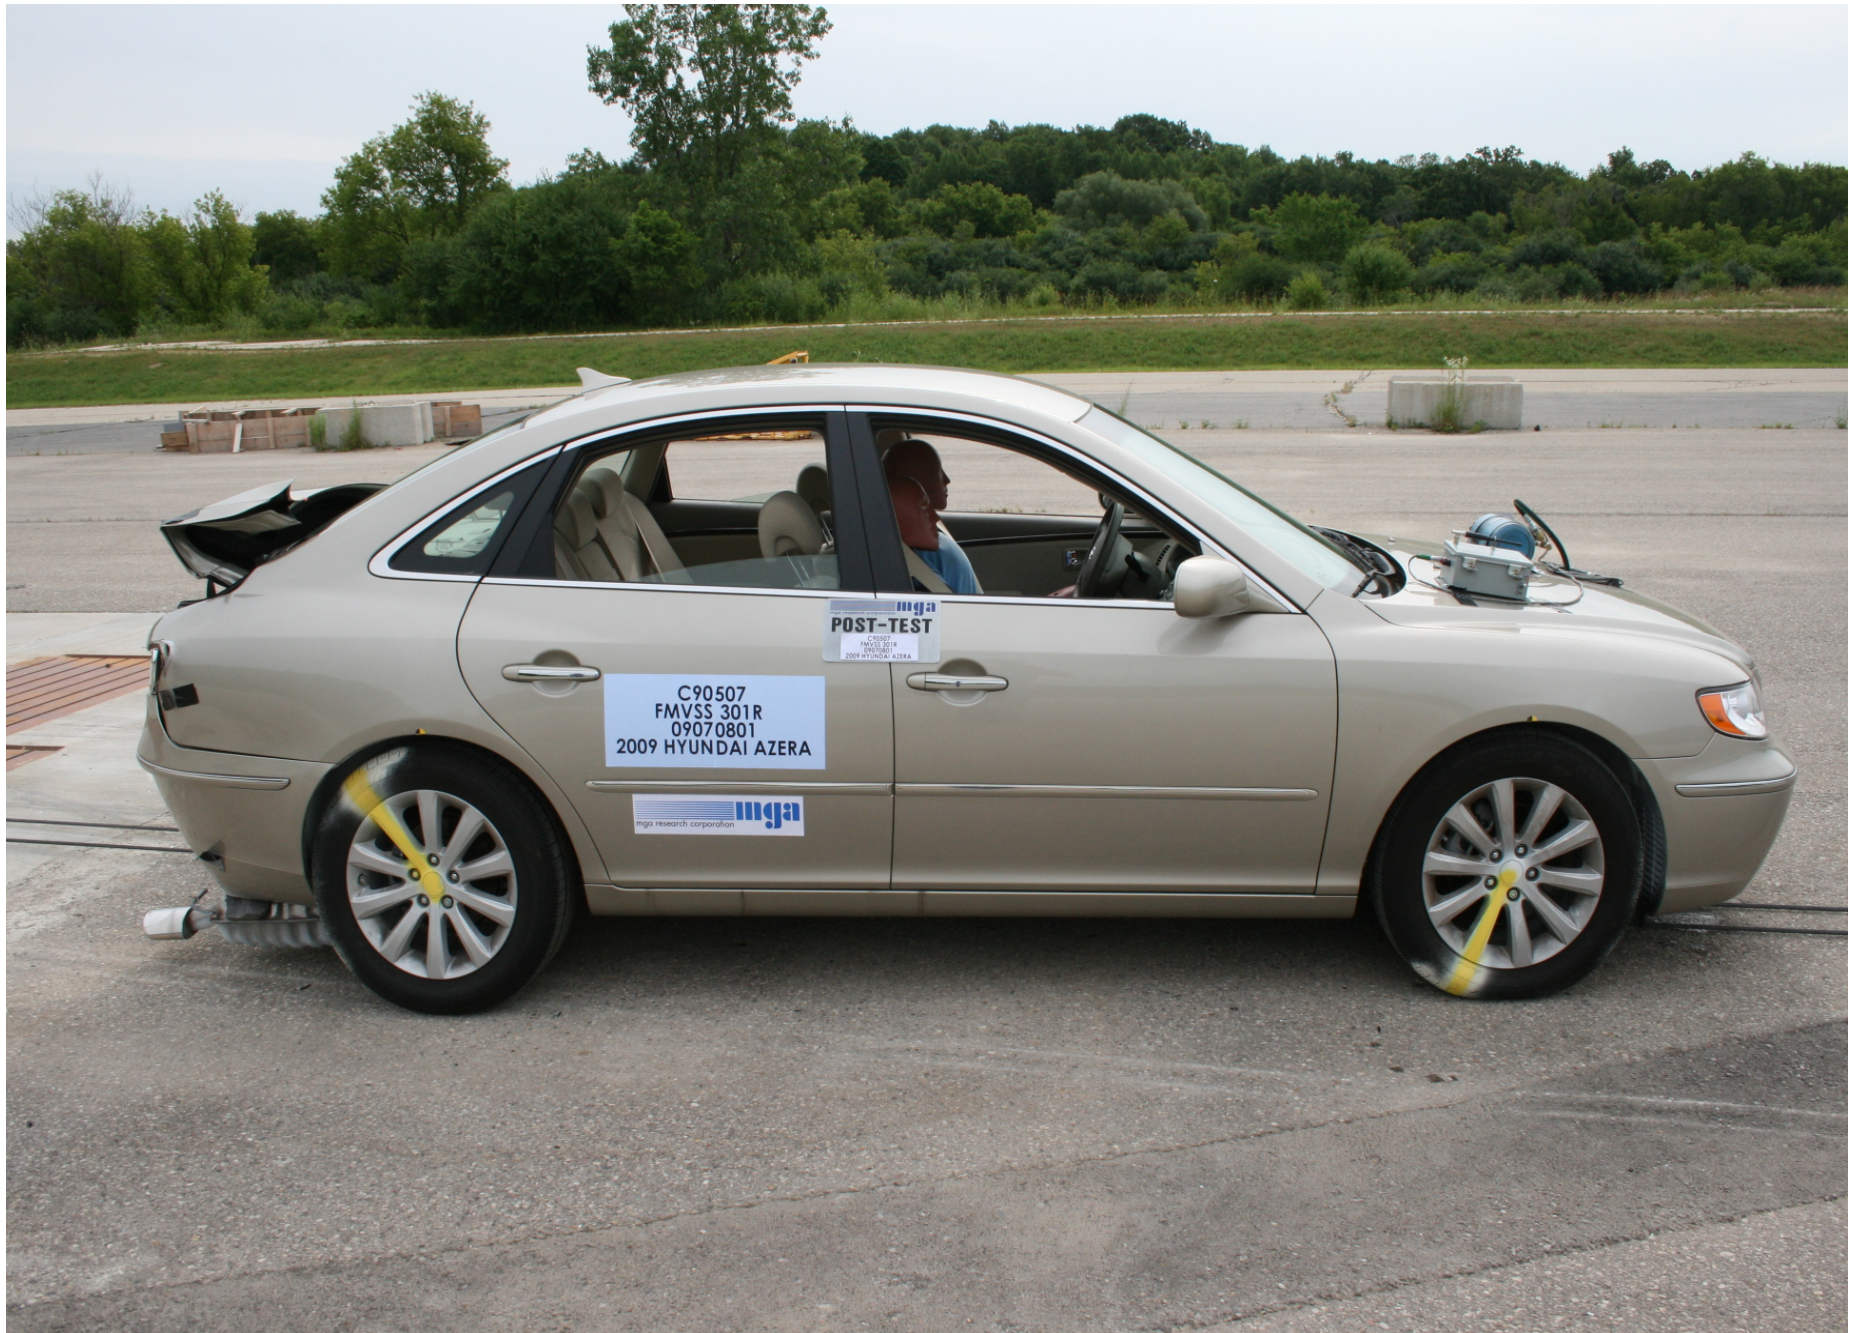
Post-Test Right Side View of Vehicle

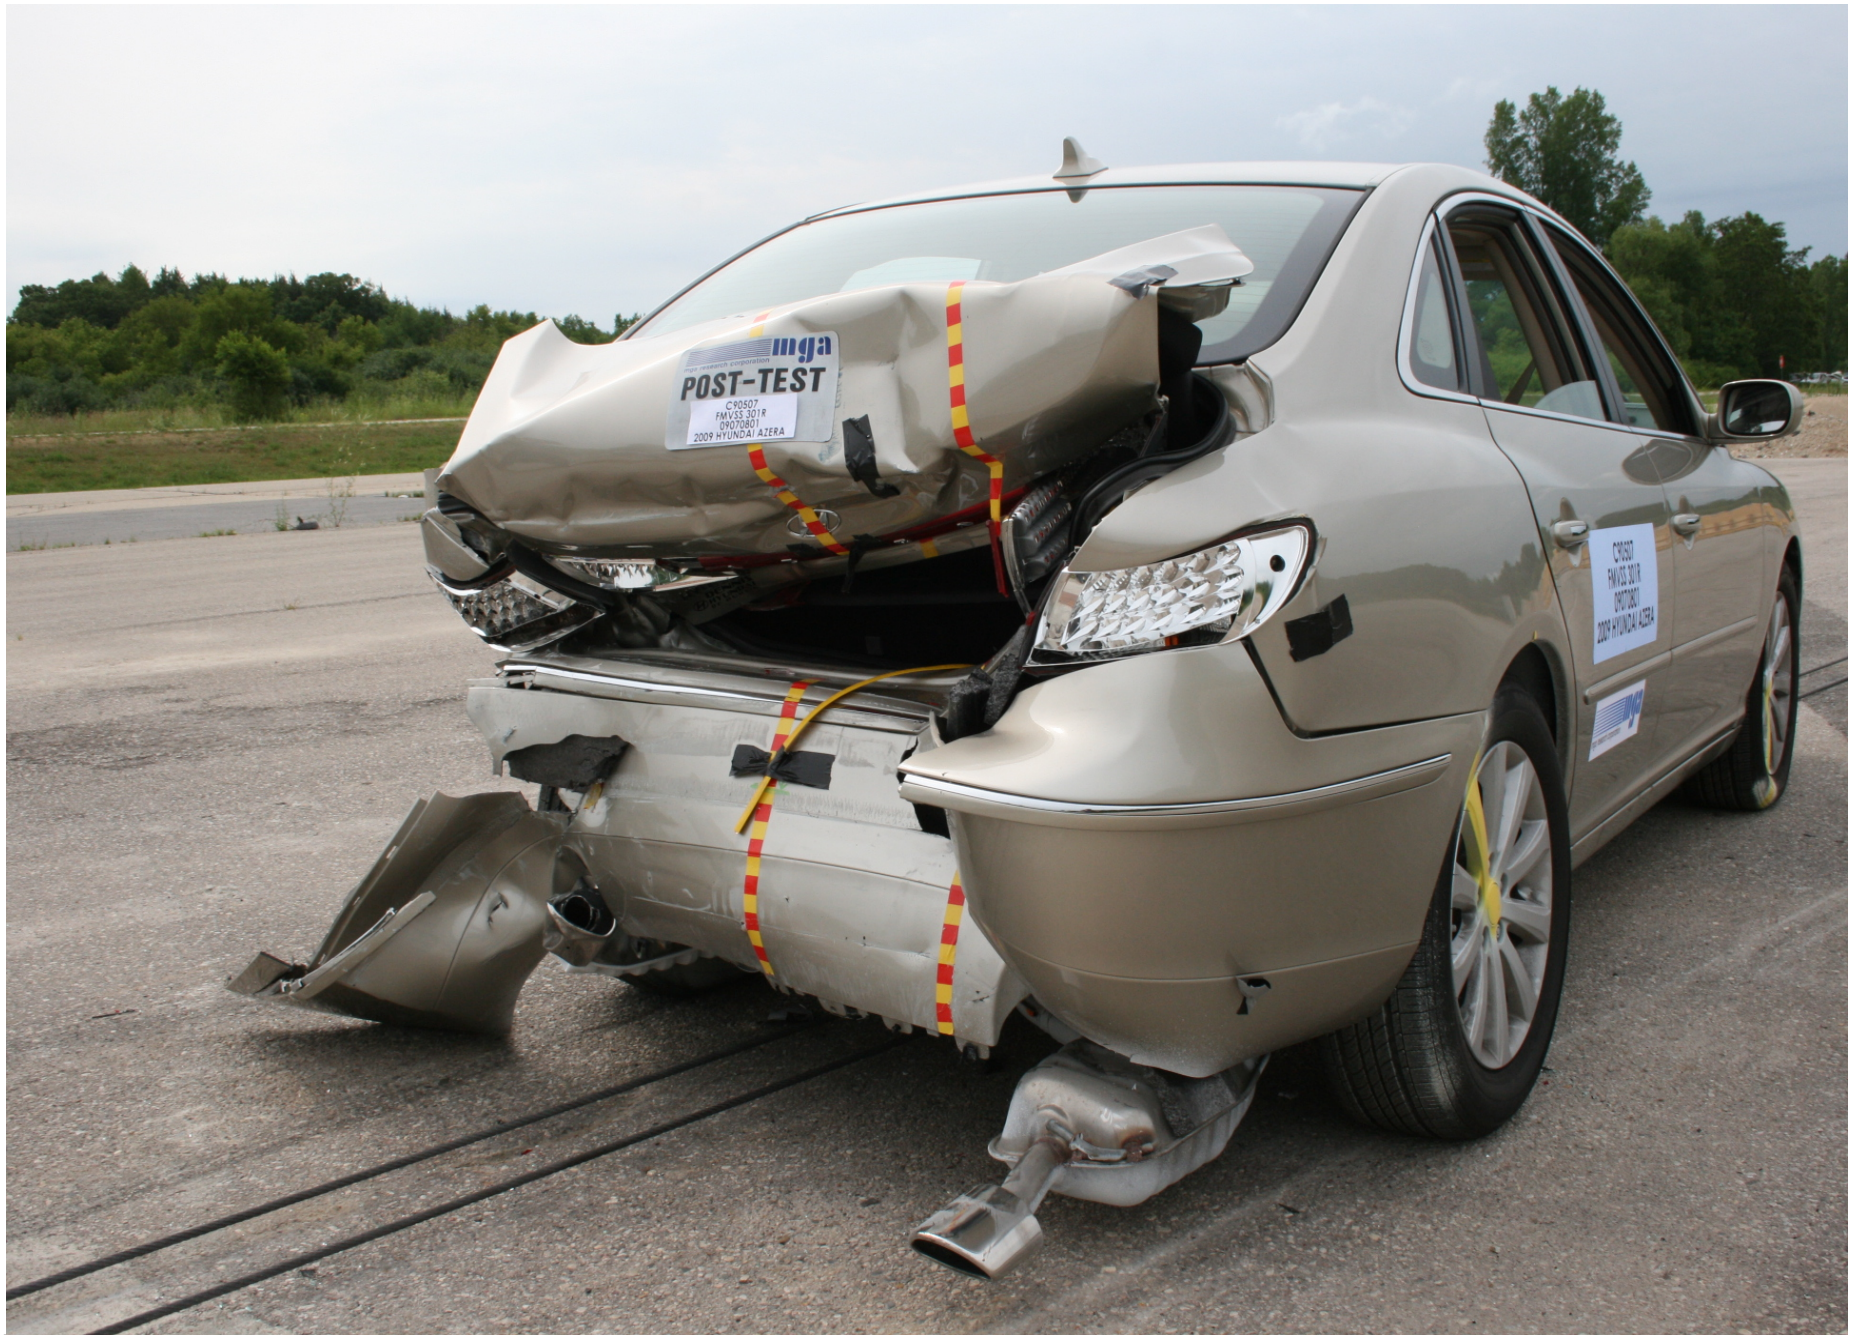
Post-Test Right Rear Close-up View of Vehicle

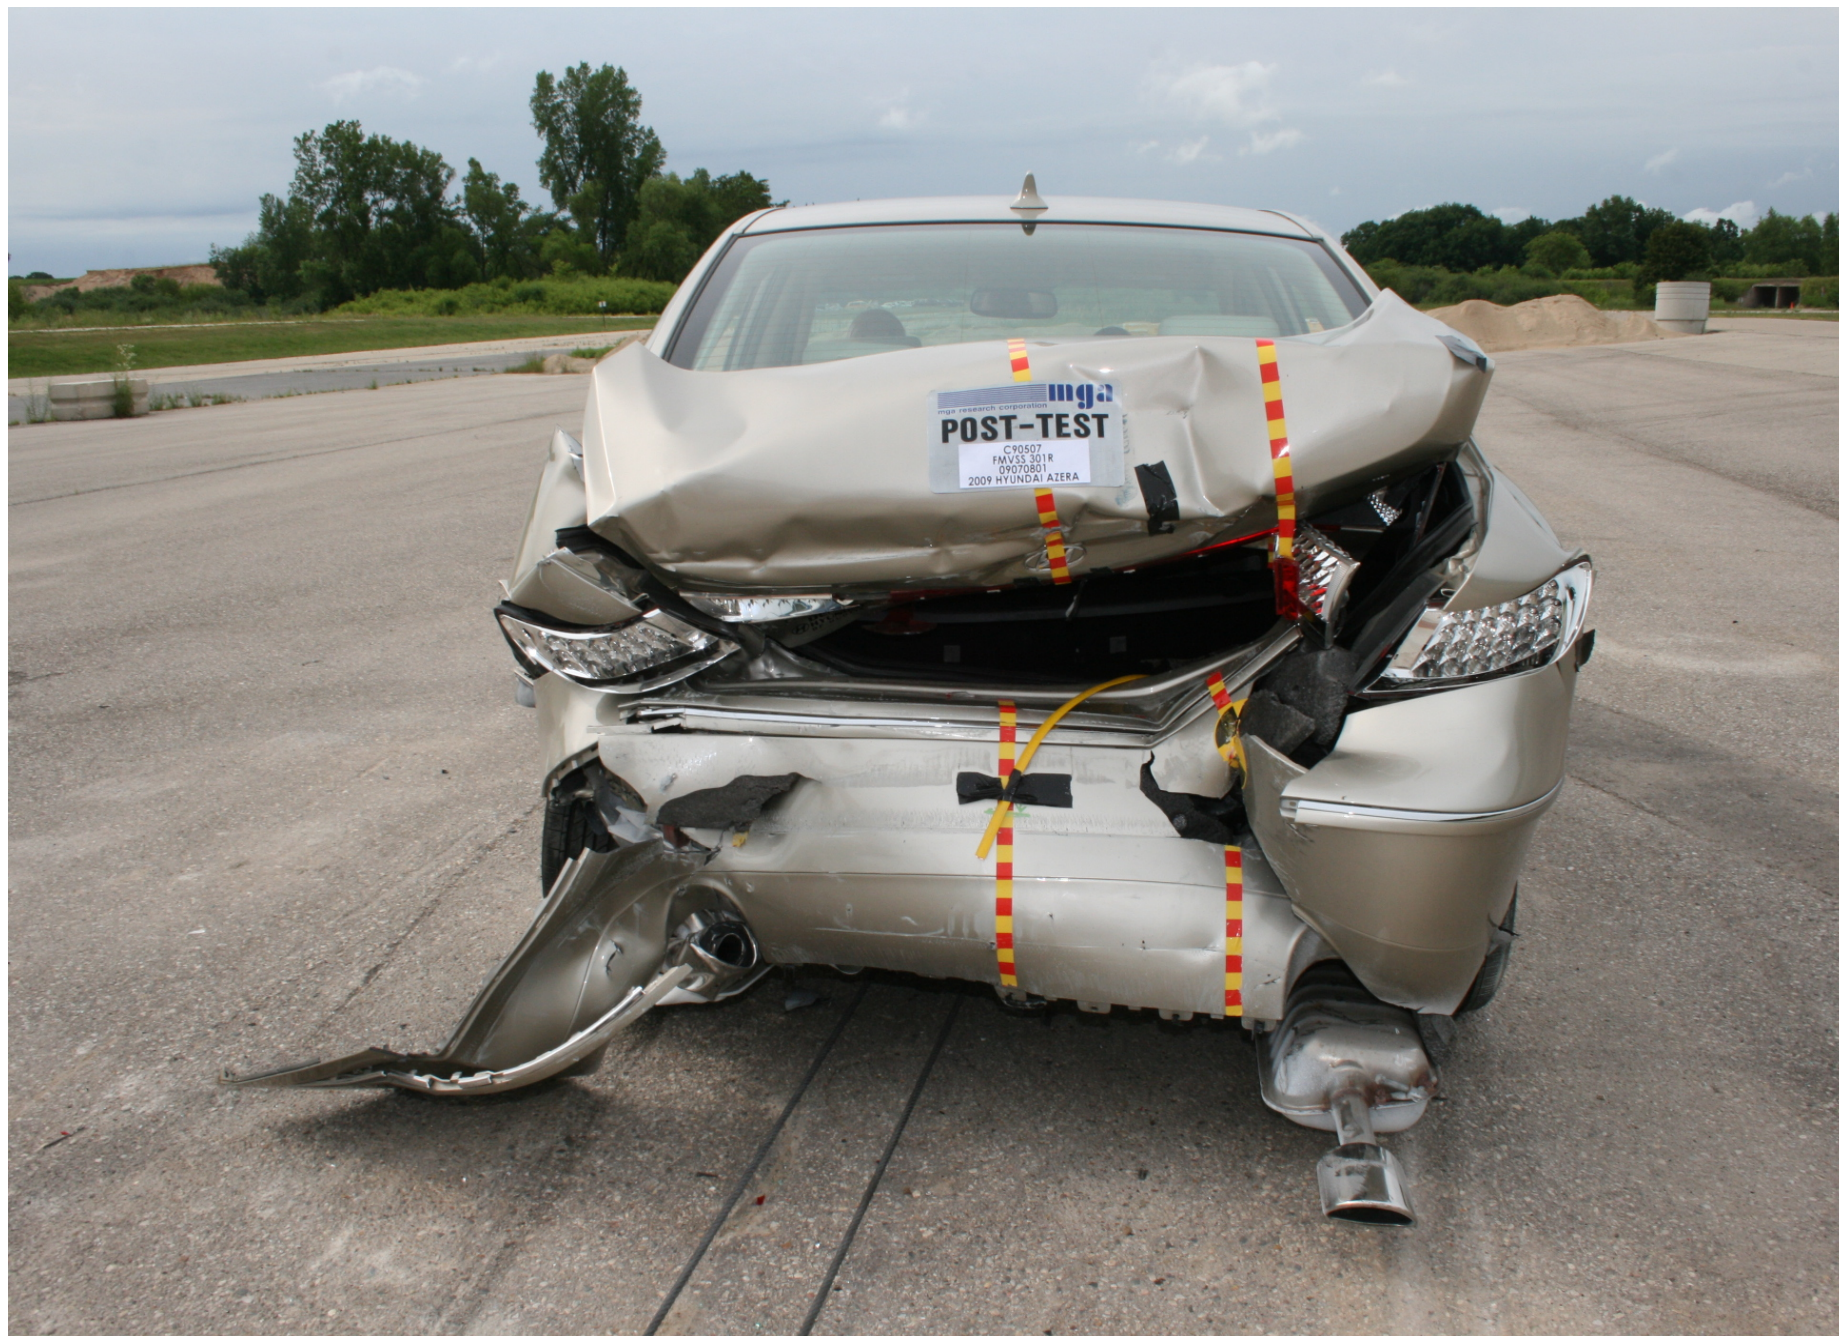
Post-Test Rear View of Vehicle

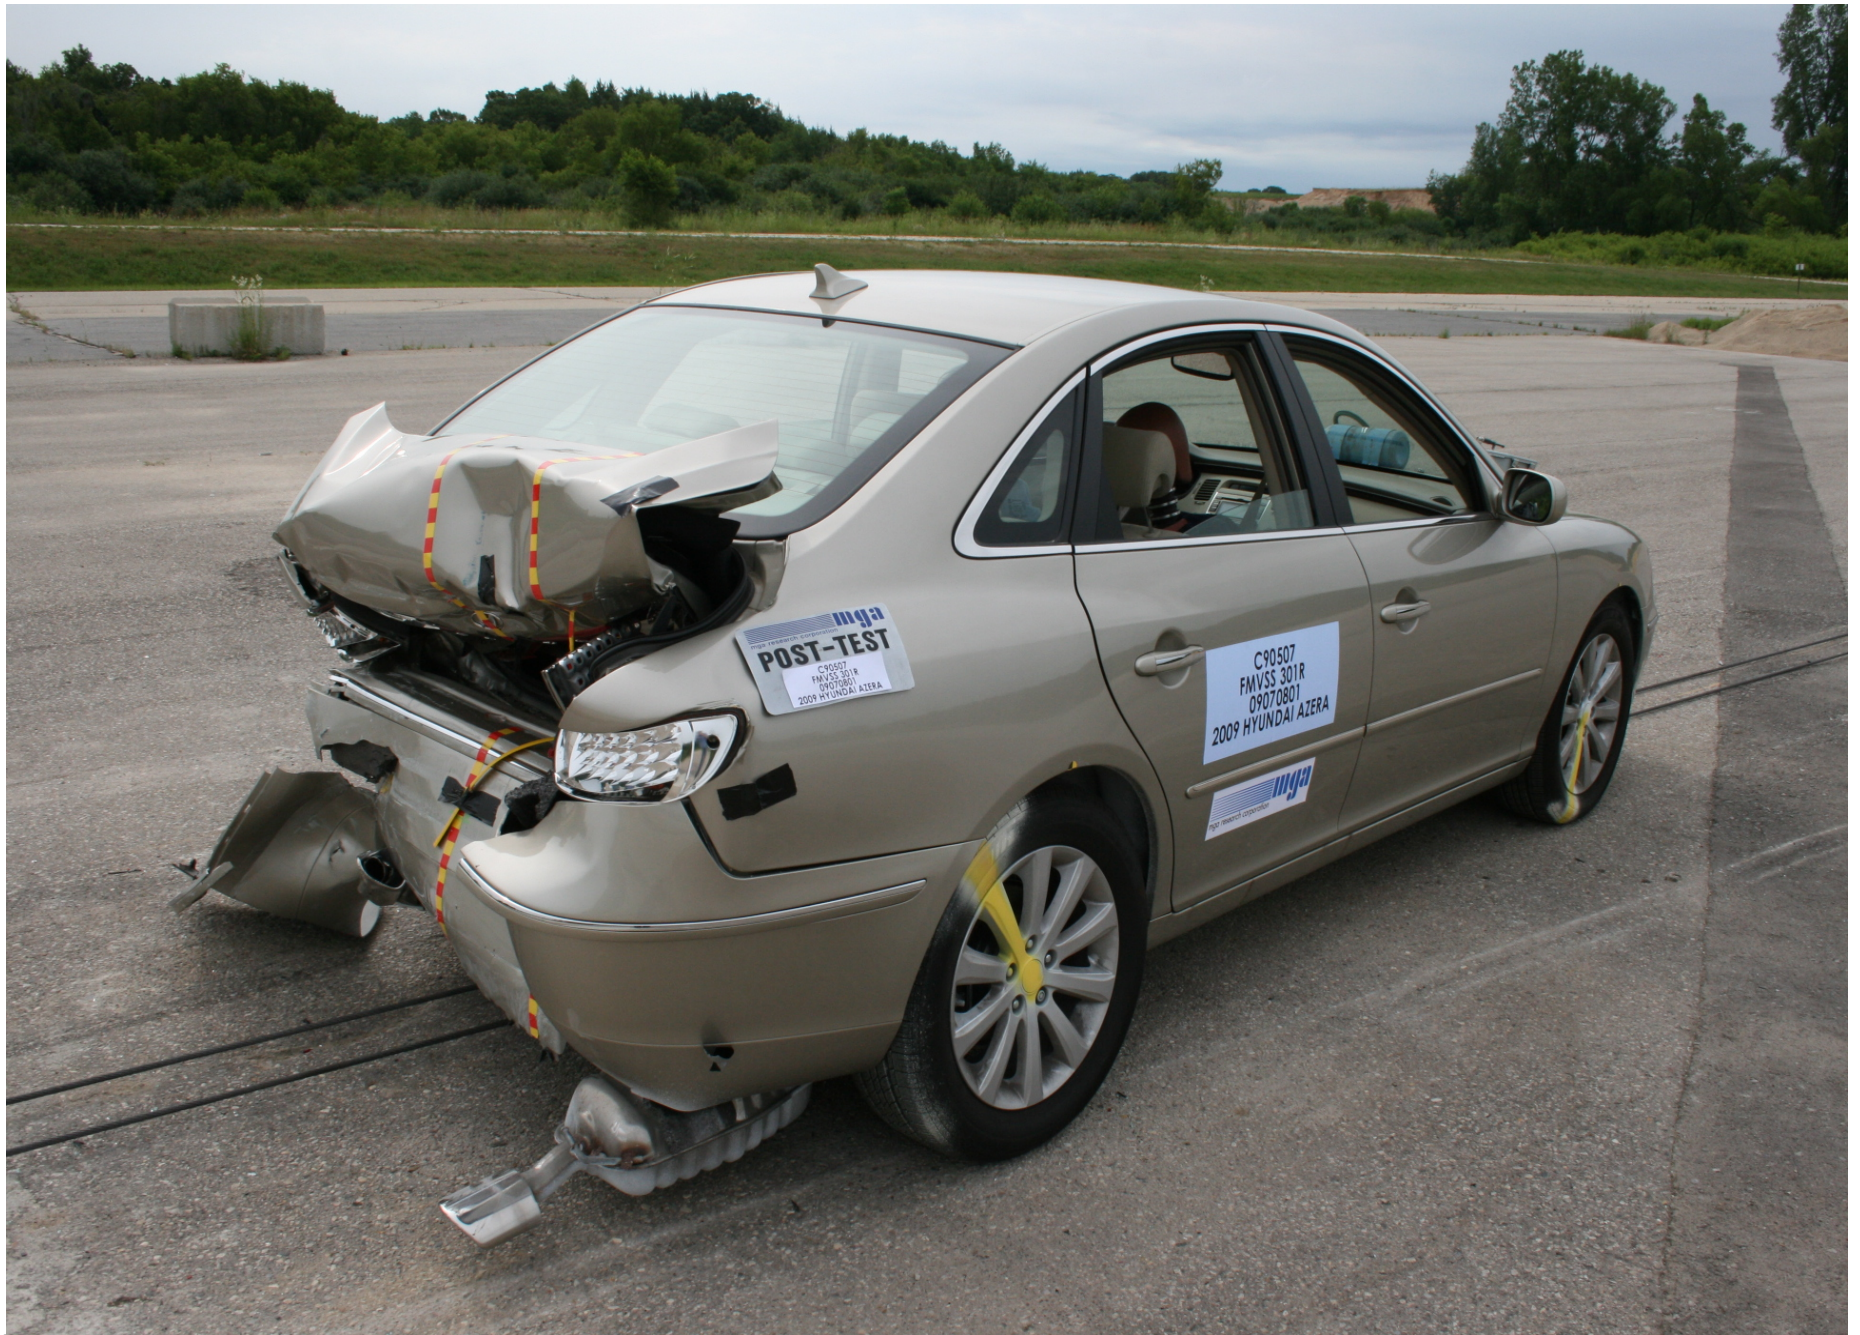
Post-Test $\frac{3}{4}$ Rear View From Right Side of Vehicle

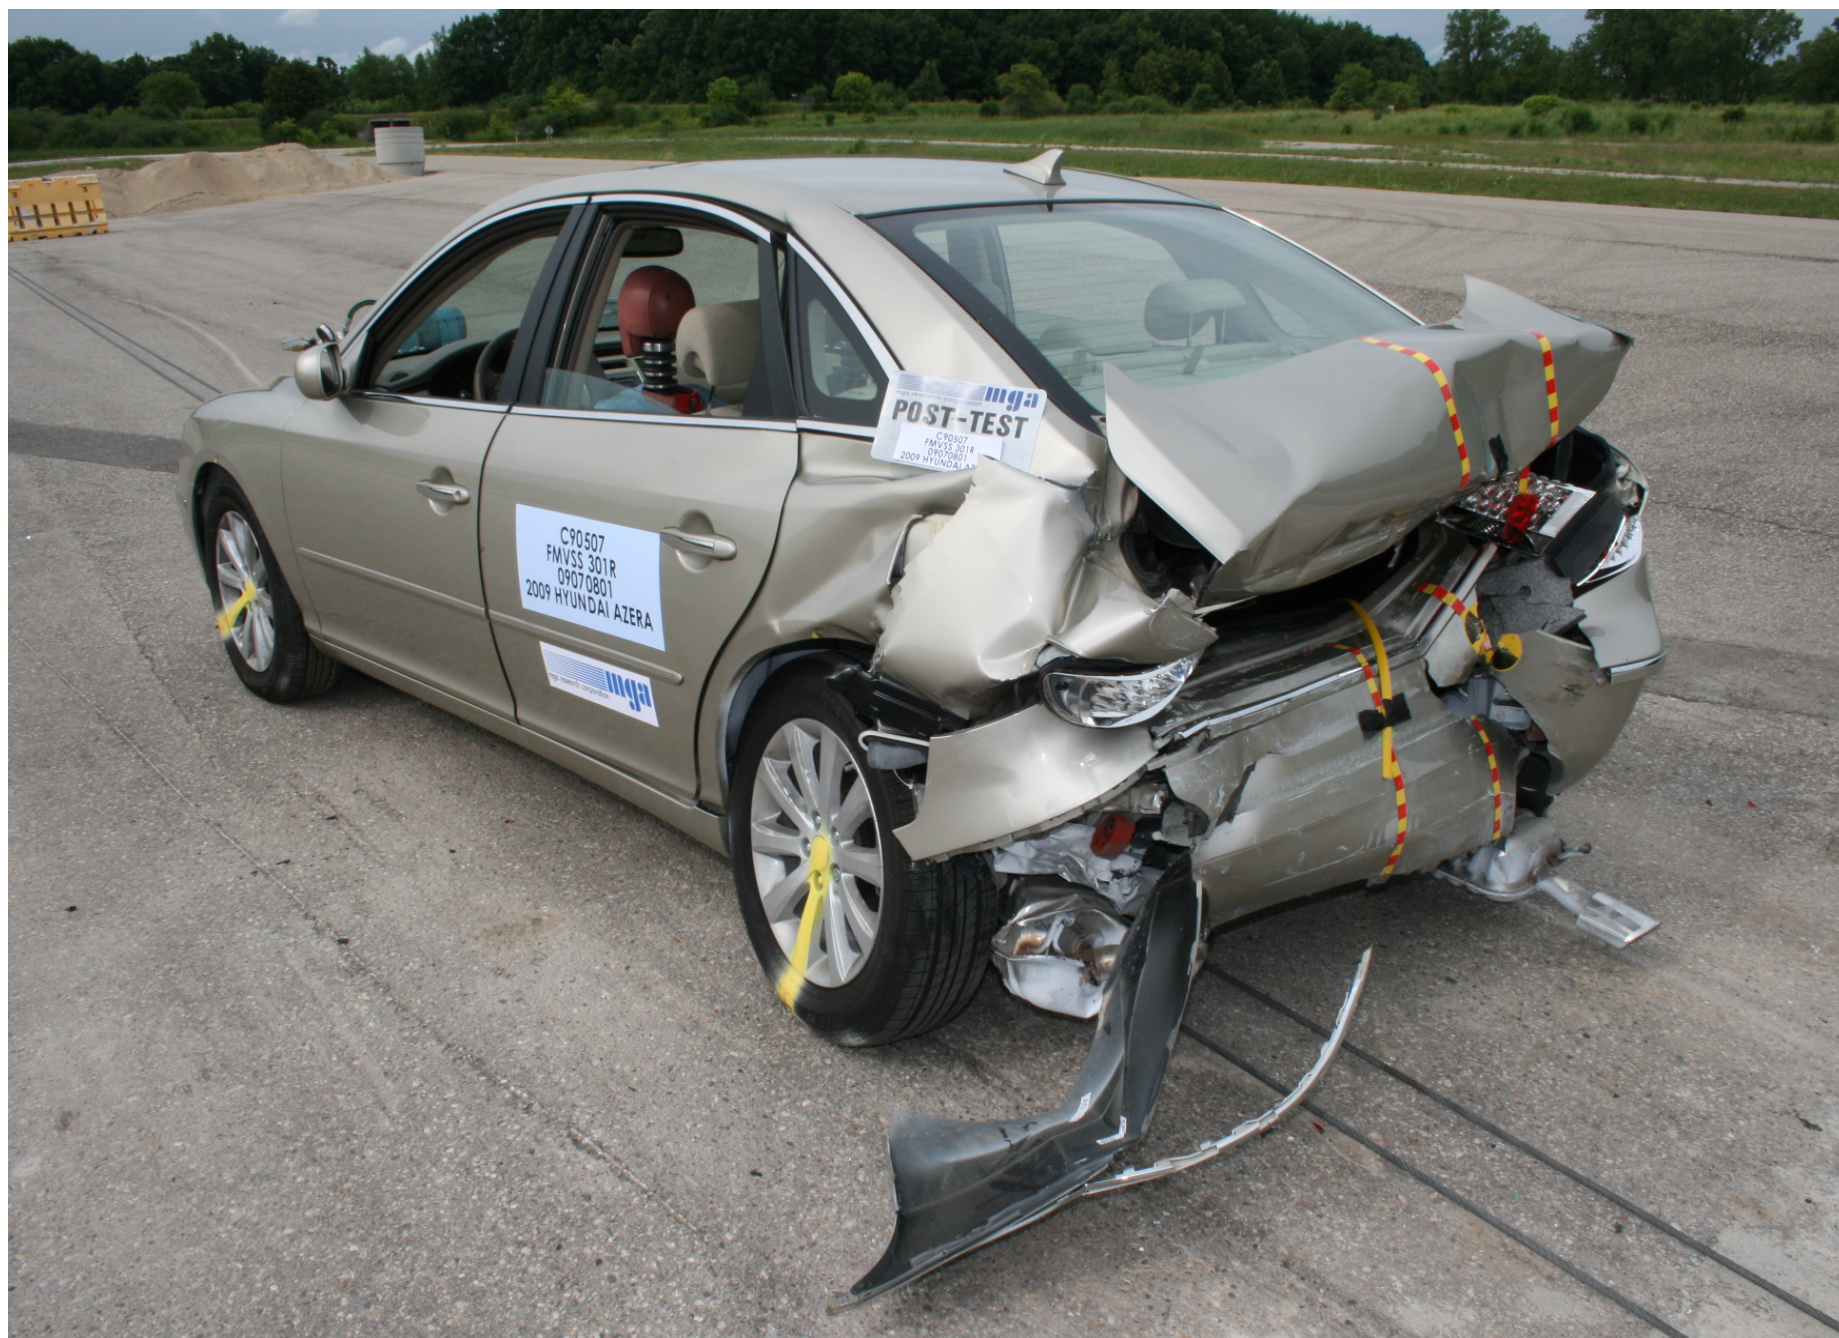
Post-Test ¾ Rear View From Left Side of Vehicle

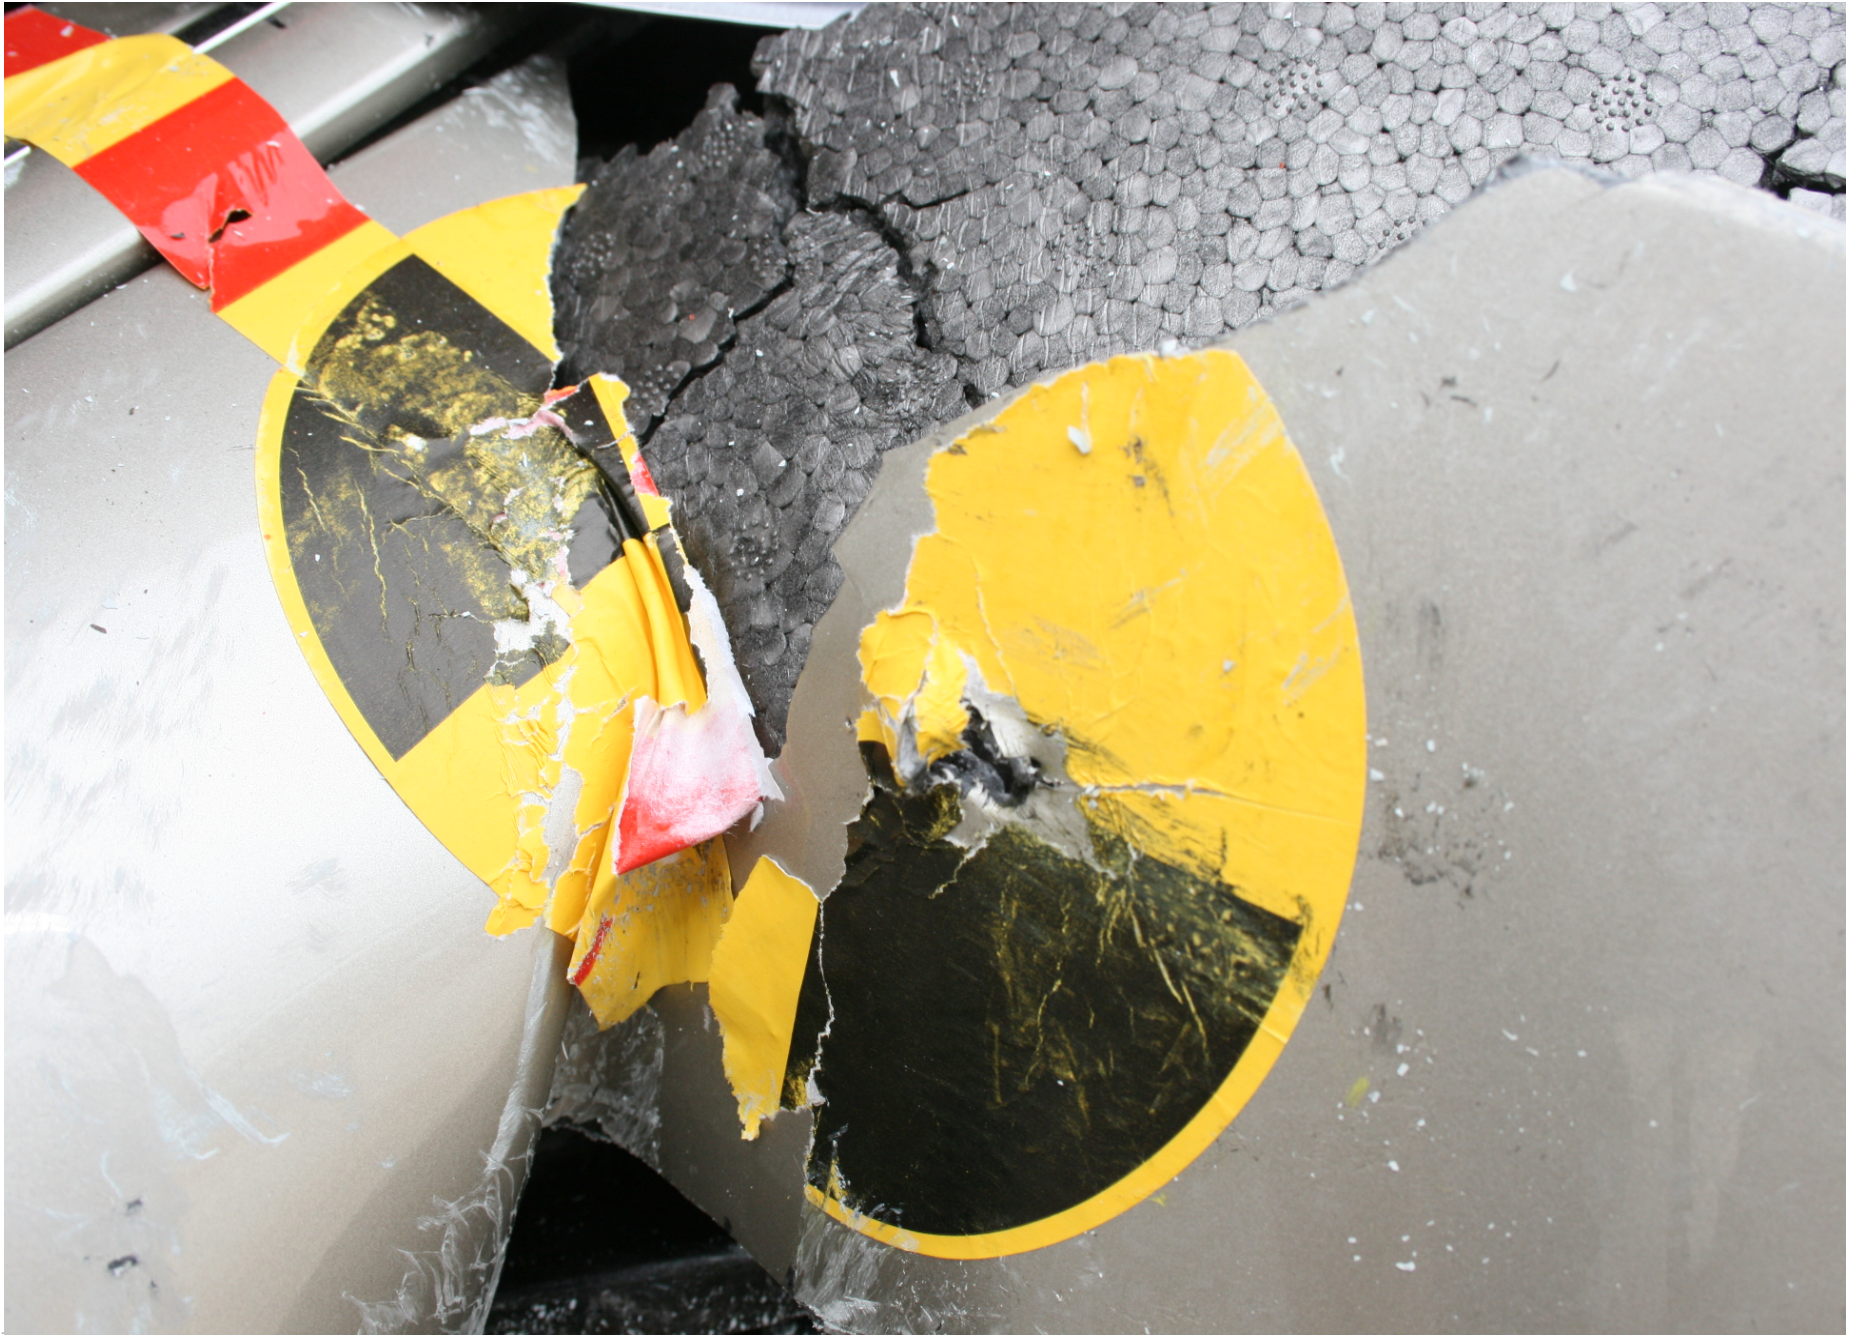
A-21.

Post-Test Impact Point
